Mobile Intel[®] Pentium[®] II Processor Specification Update

Release Date: August 2002

Order Number: 243887-043

The Mobile Pentium[®] II processor may contain design defects or errors known as errata which may cause the product to deviate from published specifications. Current characterized errata are documented in this Specification Update.

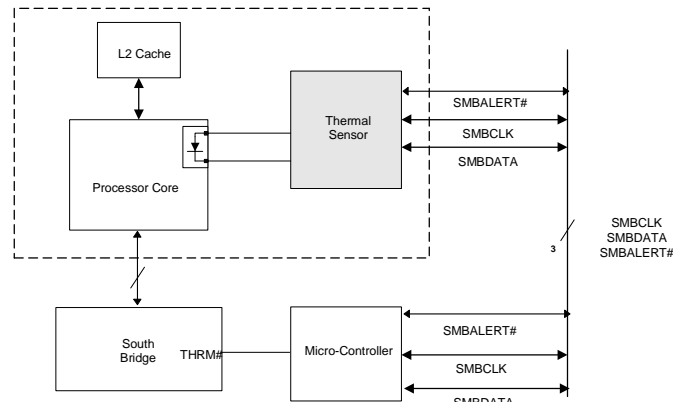
Figure 1. An Example of Microcontroller Driven Thermal Management

Problem: The Mobile Pentium II processor and the Pentium II Processor Mobile Module have a thermal sensor that monitors the processor core's temperature. Please note that desktop systems could have a similar thermal device. The thermal sensor asserts SMBALERT# if the processor temperature exceeds the temperature limits set in the Alarm Threshold Registers (T_{HIGH} , T_{LOW}). It also sets the corresponding Status Register bits to identify the cause of the interrupt. Figure 1 gives one example of the how the SMBALERT# signal could be used in a system.

Under the conditions described below, the thermal sensor incorrectly generates the SMBALERT# interrupt. All of the following conditions must be met to trigger a false interrupt:
